## The Probe Mark Discoloration on Bond Pad and Wafer Storage

Wen-Fei Hsieh\*, Henry Lin, Vincent Chen, Irene Ou, Yung-Song Lou

Ardentec Cooperation Quality Assurance, No. 3, Gongye 3 rd Rd., Hsin-Chu Industrial Park, Hukou Township, Hsinchu County 30351, Taiwan, R.O.C.

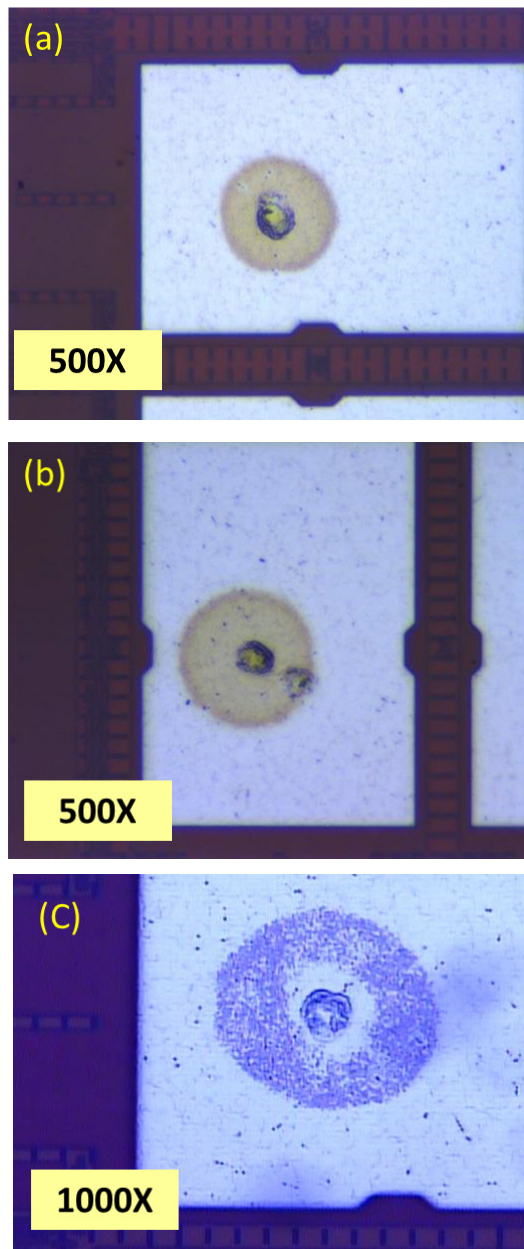
In the beginning of this case, the probe mark discoloration was found at the stage of blue tape. All the impacted wafers finished all the CP tests, and stored in the Front Opening Shipping Box (FOSB) for more than two months. There are two types of probe mark discoloration forming on the bonding pad surface. Figure 1 (a) and (c) show these typical circle/donut discoloration optical microscope (OM) photos. The special feature of discoloration morphology is that probe mark is the center of cyclic/donut center. The OM inspection for discoloration corrosion indicated most of the corrosion was cyclic, and only few was donut shaped. Figure 1 (b) show that two touchdown would not induce two discoloration. The size of cyclic discoloration is not constant, however, the largest diameter of a suffered wafer, up to 35 um, is nearly the same. With the help of full wafer dice Auto Vision Inspection (AVI), most of the corrosive dice locate near the wafer edge zone. The worst fail rate would reach up to 15-18% of all the available dice.

Figure 1: (a) show the typical probe mark discoloration OM image. (b) show the formation of discoloration on Al pad under dual pin touch down. No second discoloration is found. (c) show donut-shaped probe mark discoloration. To clearly show donut shape discoloration, (c) was magnified to 1000X, that is larger than Figure 1 (a) & (b).

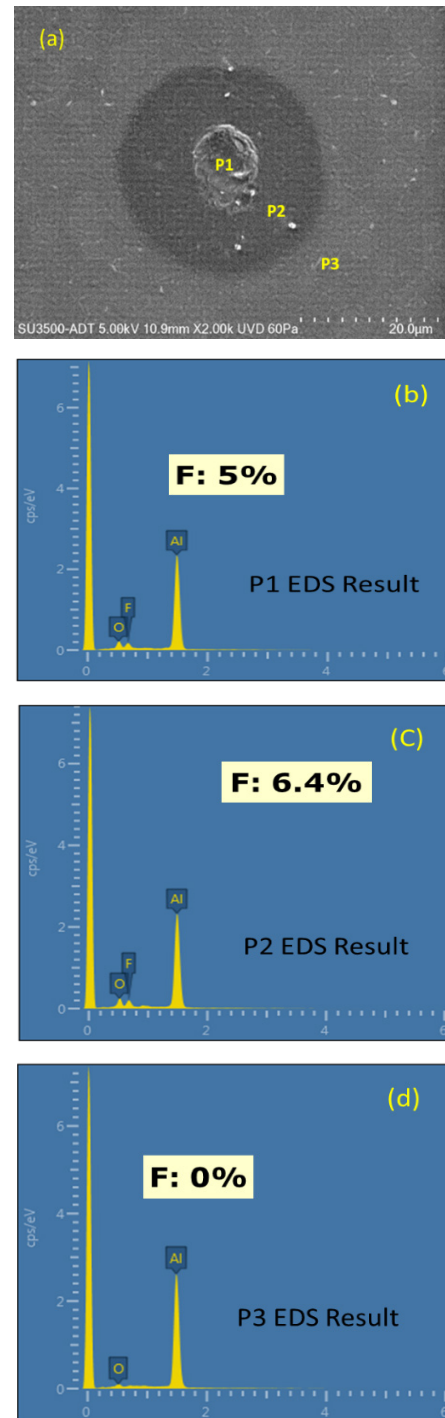
Figure 2: (a) is the SEM micrograph of probe mark discoloration corrosion. P1 is the zone of probe mark. P2 is the discoloration zone. P3 is the normal Al pad surface. (b),(c) & (d) the corresponding EDS analysis result of P1 to P3 various zones on Al pad surface. The oxygen element was found for each locations. The Fluorine was only found at the discoloration zones.

Figure 2 show the top-view SEM photo and corresponding EDS analysis results of various feature locations on Al pad surface. The SEM photo clearly show the boundary of discoloration boundary on Al pad surface. Based on the SEM inspection, the rough size of this discoloration was more than 25 micro meter. The probe mark and corresponding discoloration zone were easily identified. The SEM photo also show various morphology of probe mark surface deformation. According to the EDS results of discoloration zone, the P1 & P2 of Fig. 2(a), where fluorine and oxygen contents are found on the center and middle of circle region. No Fluorine element was detected for normal P3 Al pad surface. The content of fluorine element, 5-6 %, is noted. That is, the probe mark discoloration is a kind of aluminum-fluorine-oxygen corrosion. As for the normal zone, aluminum oxide form on Al pad surface. Since this novel corrosion product has not been fully reported before, the EDS analysis is helpful to improve the key role of fluorine element.

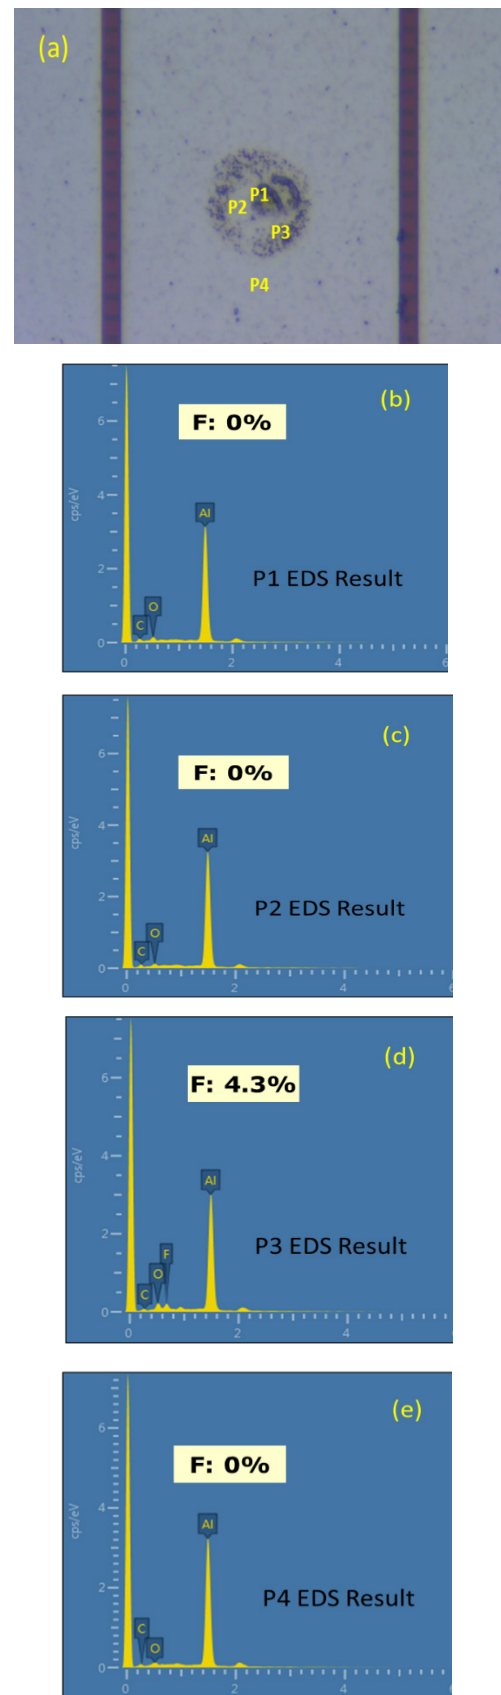
Figure 3 show the OM photo and its corresponding EDS result. P1 to P4 of Figure 3(a) are the various locations of donut-shaped discoloration on Al pad surface. P1 is the probe mark zone. P2 is the cyclic annular zone without discoloration. P3 is the cyclic annular zone with discoloration corrosion. And P4 is the normal Al pad surface. The EDS result clearly indicate fluorine element is only found at the discoloration corrosive zone. No fluorine is found at P1- probe mark, P2- cyclic annular without discoloration, and P4 - normal Al pad surface zones. Based on these donut-shaped discoloration EDS results, the root cause of the discoloration event is due to fluorine contamination. However, due to the basic characteristic of high energy electron stopping power, the X-ray signal of EDS analysis is collected not only from Al pad top surface, but also the larger undersurface bulk volume. The distribution of fluorine element could not be identified by this EDS analysis. TEM and AES are necessary for further identification.

Figure 3: (a) is the OM image of donut-shaped probe mark discoloration. P1 is the zone of probe mark. P2 is the annular zone without discoloration. P3 is the annular zone with discoloration. P4 is the normal Al pad surface. (b), (c), (d) & (e) the corresponding EDS analysis results of various zones on bond pad surface. Fluorine is only found at the cyclic annular discoloration zone.

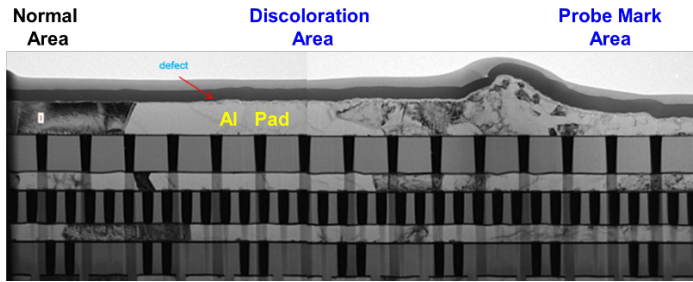
The cross-sectional TEM inspection is helpful to identify the thickness variation of corrosion film. Figure 4 show the full cross sectional TEM inspection photo of discoloration area. The thickness of discoloration corrosion film is just a few nm. Therefore, it could not be clearly identified by Figure 4. The magnified TEM photo indicate the thickness of discoloration film is uniform except for probing mark zone. Figure 5 show the High Angle Annular Dark Field (HAADF) TEM image of discoloration film structure. The HAADF image indicate the thickness of circle shape discoloration is within 5 nm. The corresponding Electron Energy Loss Spectrum (EELS) line scan results show the F & O distribution of this Al-O-F film. The fluorine is found on the top surface of corrosion film. No F & O could deeply penetrate into the Al. Figure 4 show the corrosion film of probe mark is complex. Figure 6 show the high magnification cross-sectional TEM image and its corresponding EELS data of probe mark oxidation. The variation of corrosion film thickness might be up to over 10X. The thicker film formed on probe mark zone is also the AL-O-F compound as other discoloration zone. The EELS fine structure analysis indicate discolored  $Al_2O_3$  spectrum is a combination of

Figure 4: The low magnification full cross-sectional TEM image of discoloration defect corrosion.

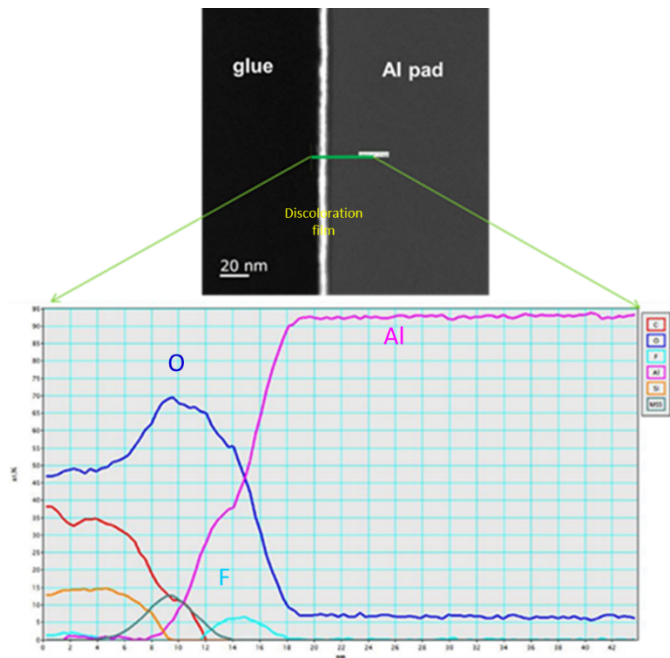
Figure 5: The cross sectional HAADF TEM image of discoloration zone and its corresponding EELS line scan result. The line scan result clearly show the distribution of fluorine and Oxygen just on the Al pad top surface.

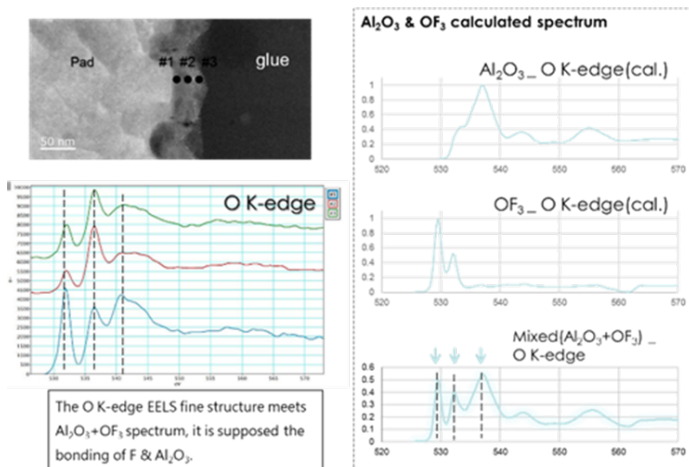
pure  $\text{Al}_2\text{O}_3$  with  $\text{OF}_3$ . That is, the fluorine diffuse into the Aluminum oxide film. F atom form a new bonding to replace O bonding. These new formed Al-O-F must be less protective than original  $\text{Al}_2\text{O}_3$  film.

Figure 6: The TEM image and EELS data of probe mark discoloration defect film & its corresponding simulation EELS spectrum.

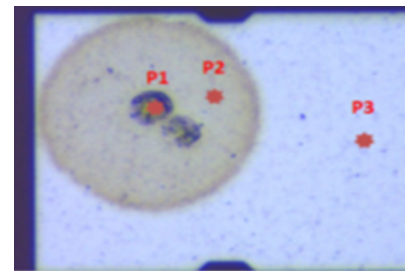
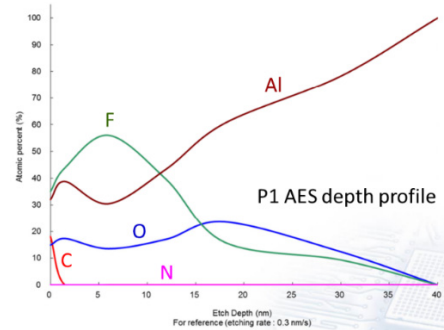
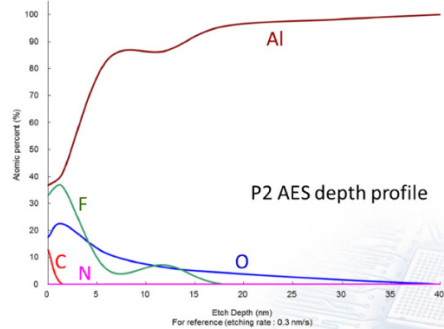
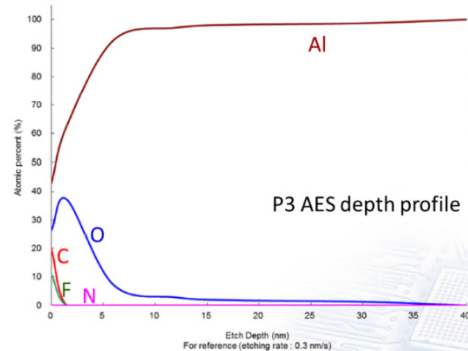
Figure 7: The OM photo and the corresponding AES depth profile of P1, P2 & P3, the P1, P2, & P3 are marked on discolored Al pad surface. P1 is the probe mark zone. P2 is the discoloration zone. P3 is the normal Al pad surface. The F element is found to co-exist with  $\text{Al}_2\text{O}_3$  at discoloration zones.

For a long time, the AES analysis is treated as the standard technology for Al pad surface contamination. Figure 7 (b) to (d) show the specific Auger Electron Spectrum (AES) depth profile result of normal/discoloration area of bond pad surface. The AES result indicate the main elements of probe mark and cyclic discoloration area are Al, F, and O. That is the same as previous EDS & EELS results. The AES depth profile results, P1, P2 & P3 of Figure 7, show the discoloration corrosion film is the F element co-existed with  $\text{Al}_x\text{O}_y$ . BTW, X-ray Photon Spectrum ( XPS ) is also an available surface analysis technology for oxidation state of

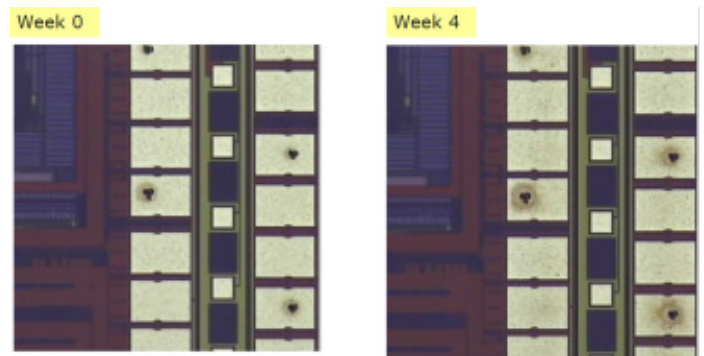
Based on the previous HAST result, all these dice were obtained from wafer center or middle area, and no extra fluorine was found. The FOSB storage test preformed for the full wafers deposited in normal FOSB at room temperature. The Ardentec AVI inspection was applied for the tested wafer before FOSB storage testing. Then these wafers, after some storage time, would be viewed by Ardentec standard AVI checking to identify the discoloration behavior on the same Al pad. After 4 weeks' storage time, obvious variation was found. Figure 8 clearly indicate the variation of two OM photos. The probe mark discoloration would deteriorate in FOSB storage test. That is to say, the fluorine-induced corrosion in the FOSB volume would be continuous. It is a manifest evidence the source of F element enhancing discoloration corrosion is due to the full wafers FOSB storage. The HAST result indicated no extra F was found from wafer center and middle area. Therefore, the source of F element of FOSB test is highly suspected to be the wafer edge or wafer extreme edge area. The EDS mapping was an excellent technology to show the various element distribution of semiconductor top surface. It would be helpful to identify the distribution of fluorine element of abnormal wafer extreme edge area.

Figure 8: show the OM inspection result after FOSB storage test. The original probe mark discoloration is the OM micrograph on the left. After 4 week's FOSB storage, the size of probe mark discoloration became larger. The right hand side OM photo clearly show this deterioration.

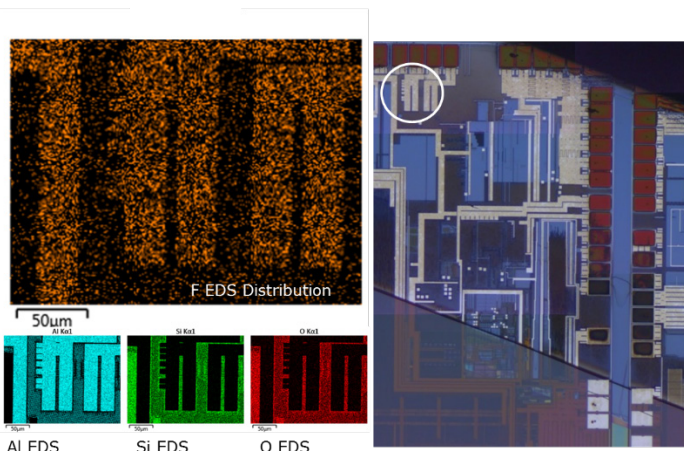
Figure 9 show the EDS mapping result of extreme edge area of discoloration wafer. The EDS data clearly show the distribution of F, Al and other main elements on semiconductor wafer top surface. And the original location of this EDS mapping, the right hand side OM photo of Figure 9, was obtained at the extreme edge of full

wafers. There is a clear boundary between extreme edge, the upper part of OM image, and the internal die area. The fluorine-induced corrosion source is clearly identified from extreme edge of full wafers. It is supposed that the FSG layers exposed to FOSB space would be the F source of this corrosion.

Figure 9: The EDS mapping result of Al pad on the discoloration wafer extreme edge area. The left hand side EDS mapping result show the distribution of F, Al, Si and O. The white circle area of right-hand side OM image shows the location of this EDS area of the wafer.

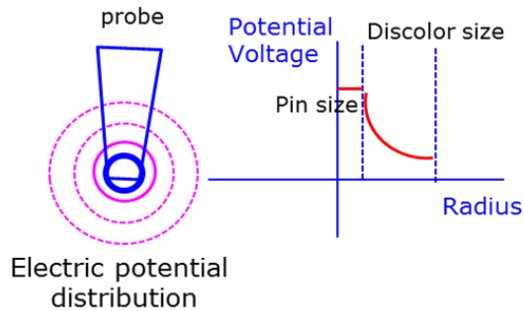
Figure 10: The critical CP testing and electrical testing potential field effect on Al bond pad surface.

The mechanism of this probe mark discoloration was proposed as follow: The CP testing would activate the embed fluorine. The formation of fluorine-contained oxide film induce this special discoloration.

temperature of 125°C setting at CP testing, and humidity, the fluorine contamination would be excited. Here the water is supposed to play an important role, leading to forming of hydrogen and oxygen, and after serial chemical reaction with fluorine, the Al<sub>x</sub>O<sub>y</sub>F<sub>z</sub> compound form. This kind of Al<sub>x</sub>O<sub>y</sub>F<sub>z</sub> compound is the discoloration by OM inspection. The threshold activation energy for all the chemical reactions was limited by electric potential field built by testing program, therefore, electric potential field introduced the circle shape discoloration region centered by probe mark. Figure 10 show the electric potential field distribution build by probing test.

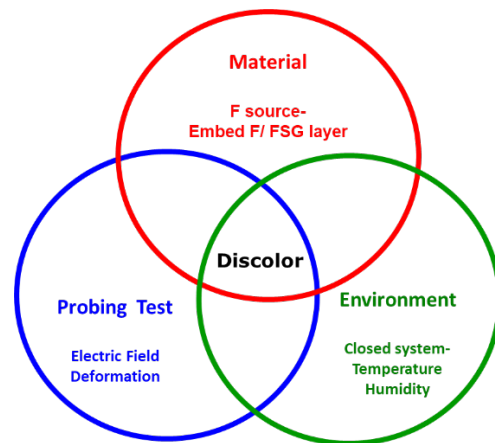
The formation of probe mark discoloration on Al pad surface was not just due to single factor. There are three complex factors to induce this corrosion. The first factor is the sufficient fluorine supply in wafer storage environment. The fluorine might come from bond pad top surface or wafer inter metal dielectric layer. The second one is the environmental condition. The suitable temperature and enough humidity are critical to accelerate the fluorine corrosion reaction. The third factor induce probe mark discoloration formation was the probing touchdown and its sequential current and electric field. According the early study [3], the Al-O-F compound on Al pad surface show different morphology as this corrosion event. No previous report had pointed this Al-O-F compound discoloration morphology with probe mark as its circle center. Therefore, the characteristic of this contamination closely related to electric probing test condition. Then this novel probe marked discoloration need to combine all the above corresponding factors. These factors are materials property, wafer testing/storage environments and probing testing. Figure 11 show this idea.

Figure 11: The factors to induce bond pad probe mark discoloration. These critical factors are material property, probing test and environment.

According to the above mechanism, the formation of probe mark discoloration could stop in some ways. The material itself decide the source of fluorine. Therefore, the content of fluorine embedded on bond pad top surface or the distribution of fluorine on wafer edge is an important index to find the fluorine source. Since in CP and FT daily operation, no fluorine contained chemical materials are used. The CP & FT Fab is better to take them into regular monitor index for future discoloration event.
